The Royal Mail Ship *Titanic*: Did a Metallurgical Failure Cause a Night to Remember?

Katherine Felkins, H.P. Leighly, Jr., and A. Jankovic

A metallurgical analysis of steel taken from the hull of the Titanic's wreckage reveals that it had a high ductile-brittle transition temperature, making it unsuitable for service at low temperatures; at the time of the collision, the temperature of the sea water was -2°C . The analysis also shows, however, that the steel used was probably the best plain carbon ship plate available at the time of the ship's construction.

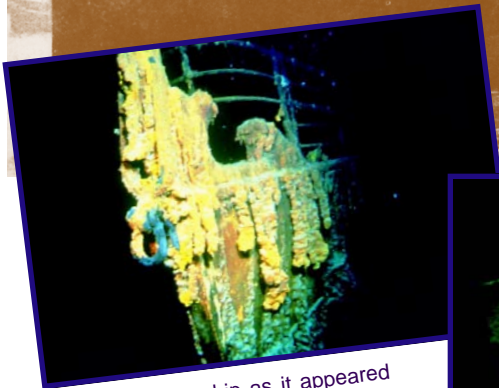
The bow of the ship as it appeared during a 1986 expedition. (Photo courtesy of Woods Hole Oceanographic Institution.)
