Shattering glass cookware

R.C. Bradt and R.L. Martens

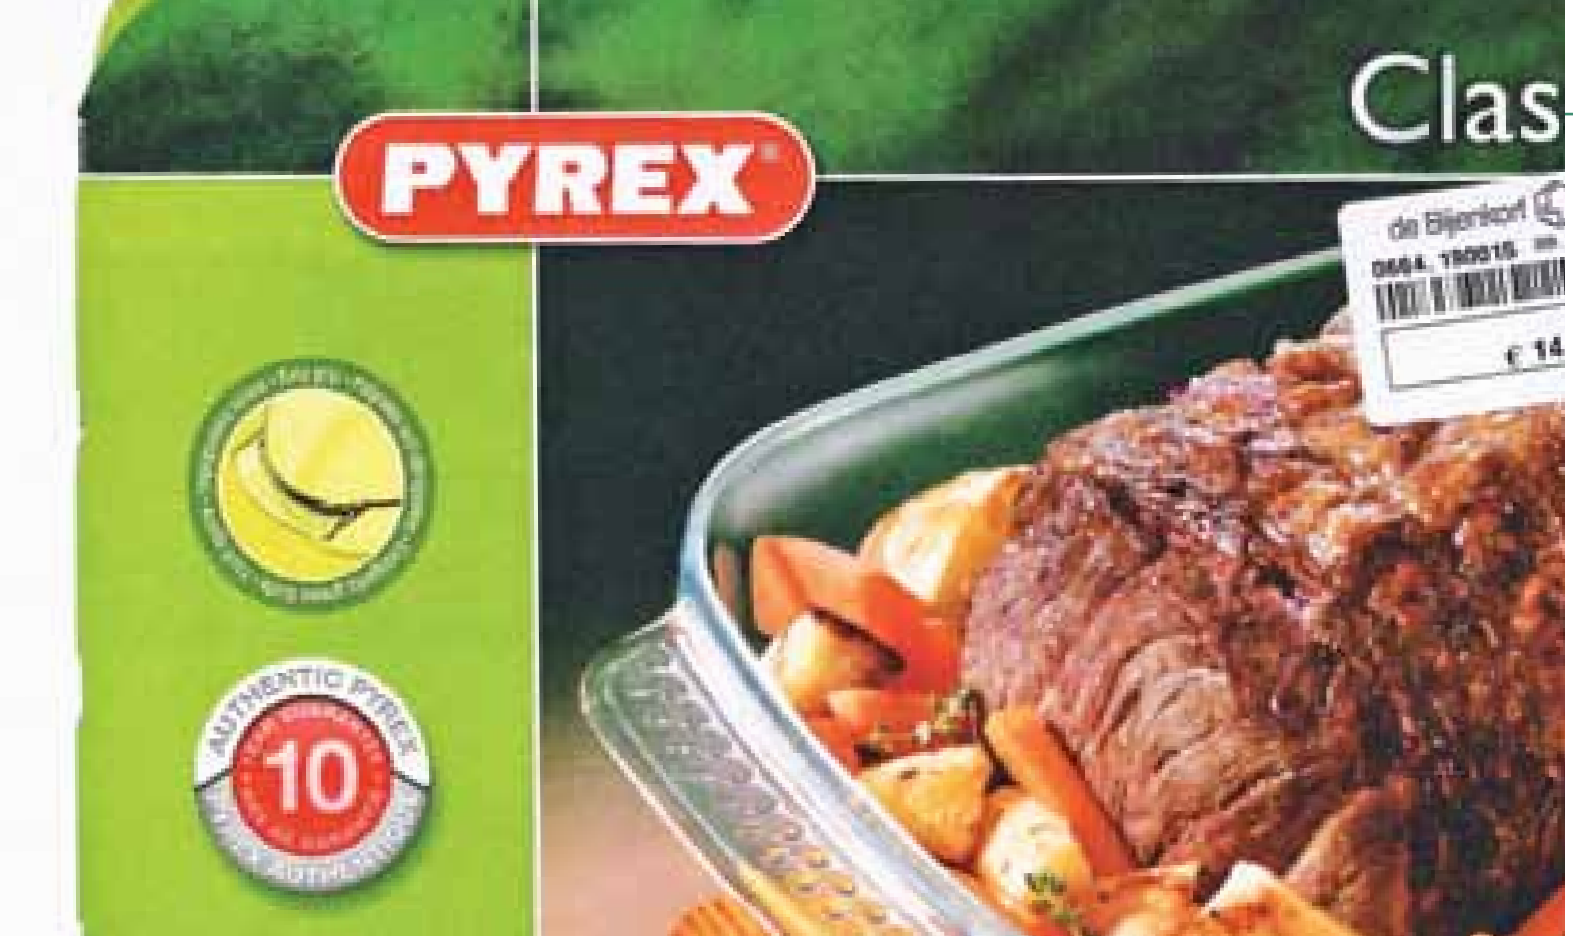
Figure 1. An Arc International label for its Pyrex glass cookware products, from cookware purchased in Europe.

Arc International produces a line of glass cookware products. These are of a borosilicate glass composition, which it markets with the phrase "Authentic Pyrex" on the label (Figure 1).[††]

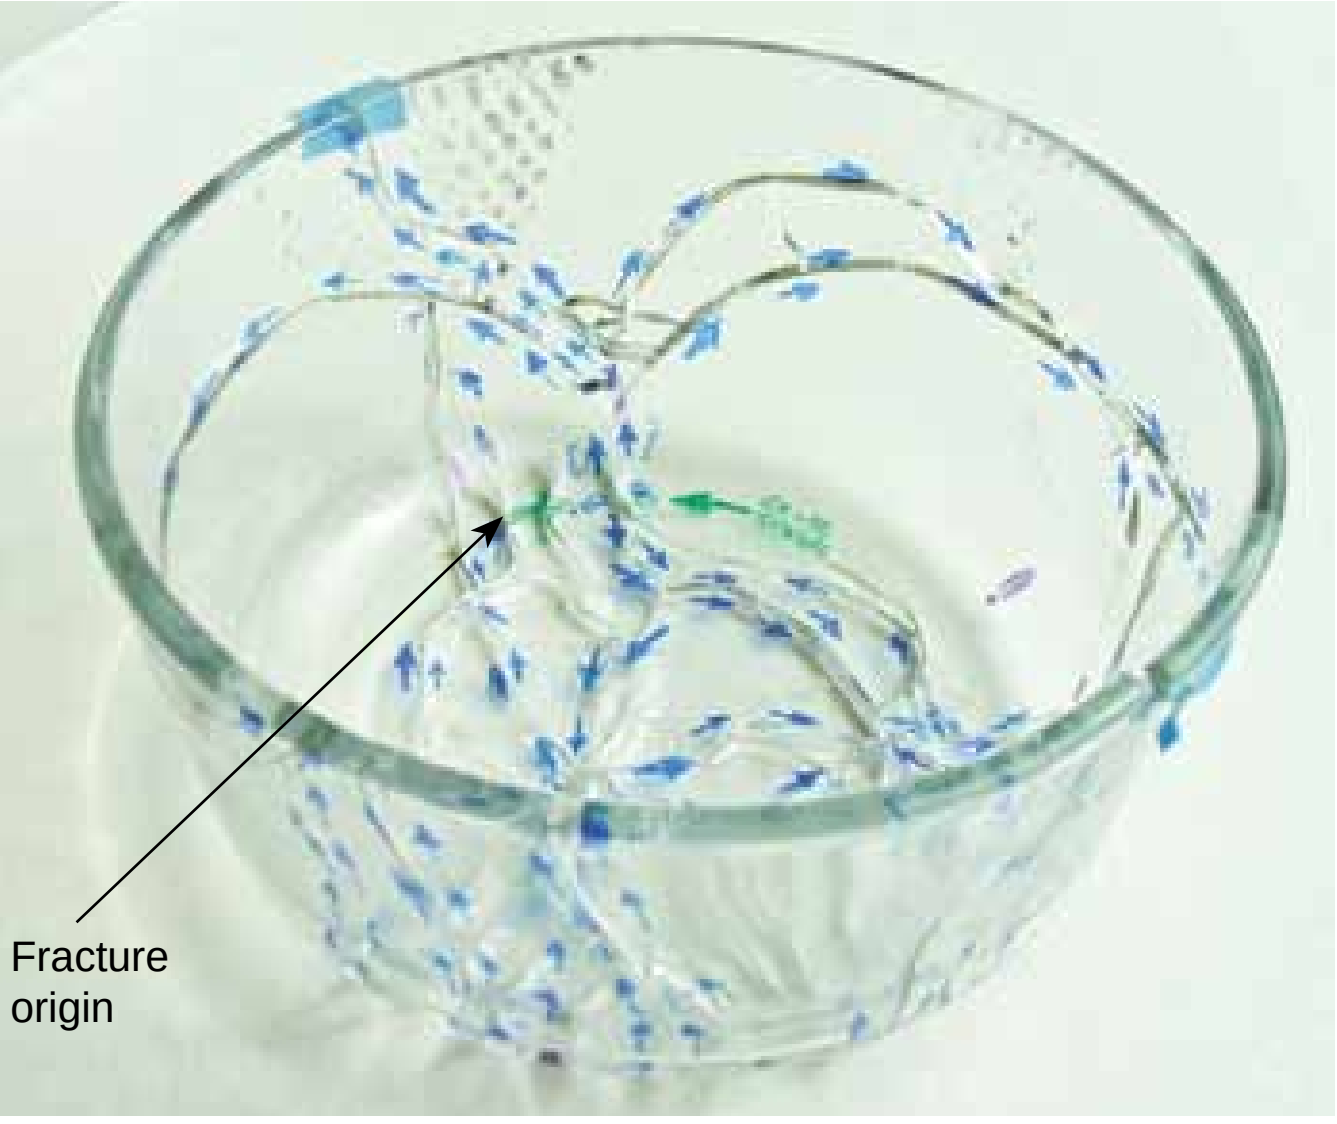
The authors' examination of fracture pieces of several dishes, including some that were intentionally broken by thermal stress and some by impact, revealed no dicing fragmentation. The soda lime silicate cookware consistently fractured into extended glass shards.

The large shards produced by the fracture of the soda lime silicate cookware imply that the thermal or heat strengthening of the soda lime silicate cookware was not substantive. Figure 3 illustrates a reconstructed "Pyrex" bowl that was purchased new and intentionally thermal shocked in a household kitchen. There is no evidence of dicing fracture. The occurrence of long sharp glass shards is also described in numerous reports on the Internet and in the CPSC literature.

Figure 3. A reconstructed soda lime silicate Pyrex bowl fractured by thermal shock. Arrows outline the crack paths.

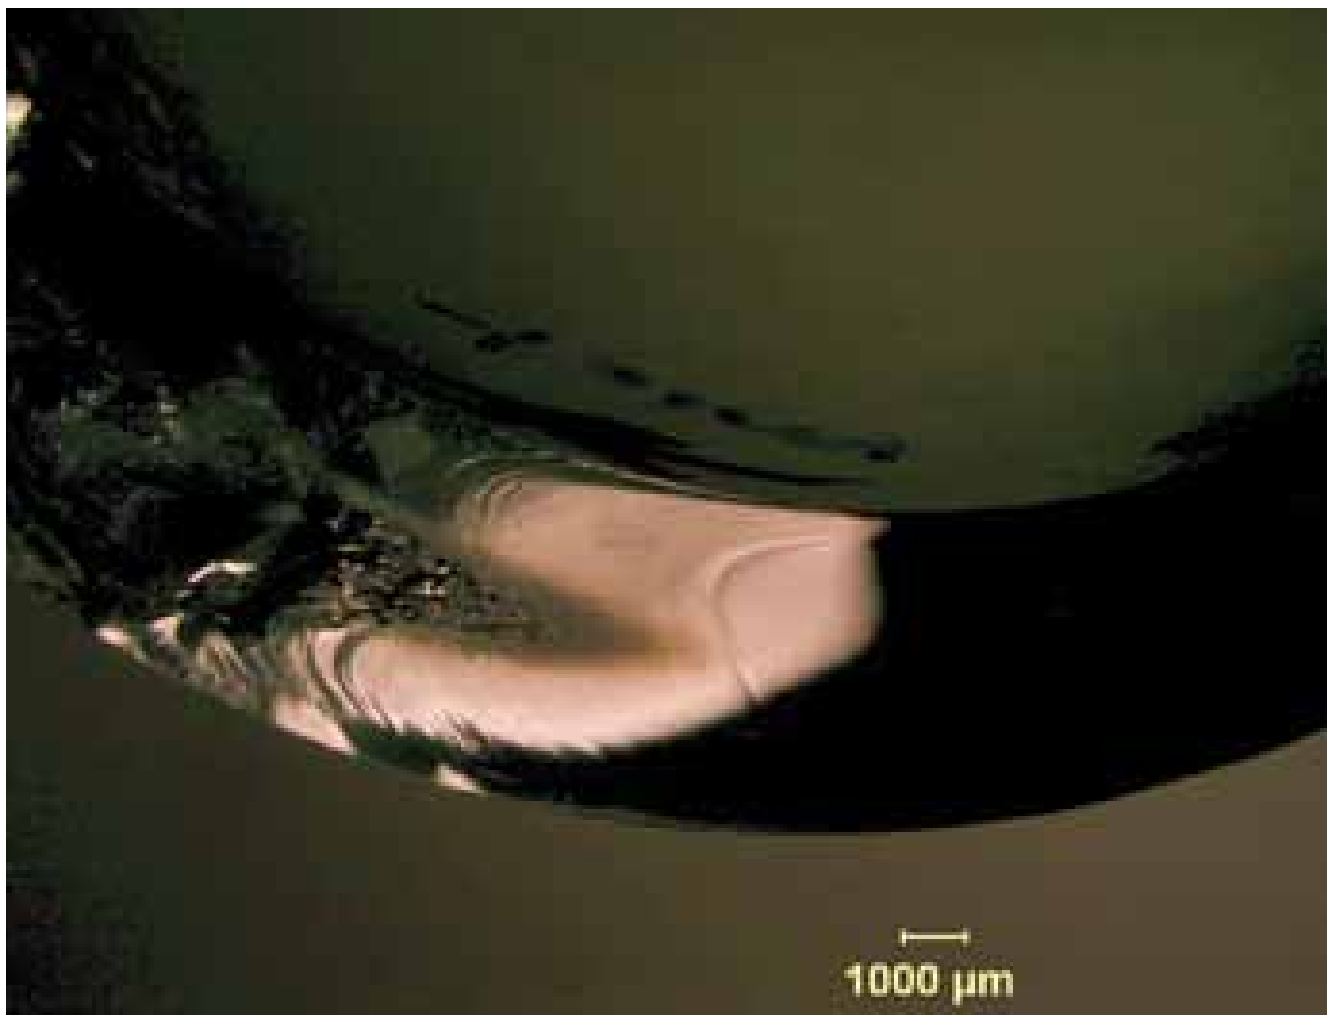
Indeed, the crack growth pattern on the fracture surface of shards of soda lime silicate glass cookware, as shown in Figure 4, indicates that the soda lime silicate glass has been heat strengthened. Note the Wallner line ripples on the cross section clearly are trailing at the glass surfaces, indicative of surface compressive stresses. (Wallner lines are slight ripples on a fracture surface that are indicative of the direction of crack propagation and the state of stress.)

Thus, although the cookware definitely has been heat strengthened as stated by the manufacturer,[19] it does not appear to be sufficient to increase substantially the thermal stress fracture resistance of the cookware, nor is it sufficient to create a desirable dicing fracture pattern for the glass cookware.

Figure 4. The fracture surface of a soda lime silicate glass cookware bowl (from bowl in Figure 3) as it formed during thermal shock failure. Note the Wallner lines trailing along the surfaces, inside and out, are indicative of heat strengthening of the glass during manufacturing.[22]
