## Fatigue Beachmarks and Striations

AME 60646: Failure of Materials (R.K. Roeder) —

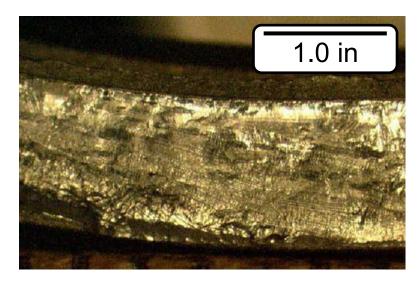
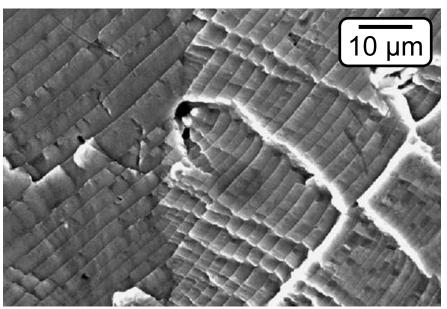
Aluminum component in aircraft landing gear.

Beachmarks
